### **D.6.3.1. 1st proof of concept demonstrator of line fault detector**

**Henry Rimminen, Anu Kärkkäinen, Heikki Seppä**  
**VTT Technical Research Centre of Finland**

## Line current indicator prototype

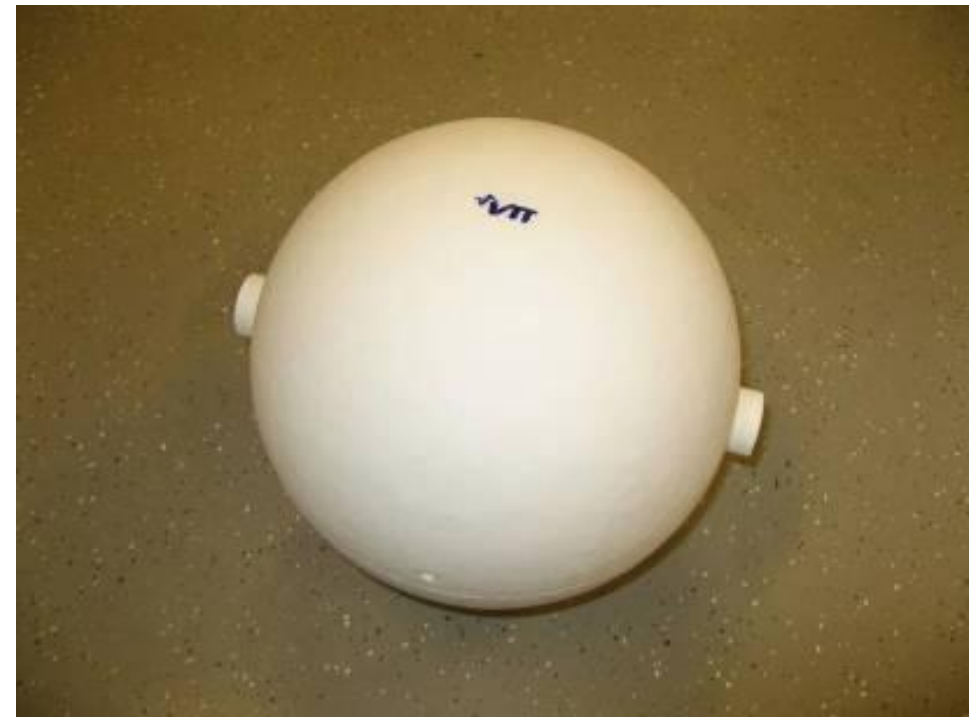
- Measures line current
- Intended use is on 20 kV power lines
- No battery changes needed because harvests operating energy from the power line using a current clamp
- Radio communication
- Folding snap-on structure
- Up to 20 mm  $\varnothing$  wires
- Cost of the single prototype €60, of which €35 consists of the radio (enclosure is not included)

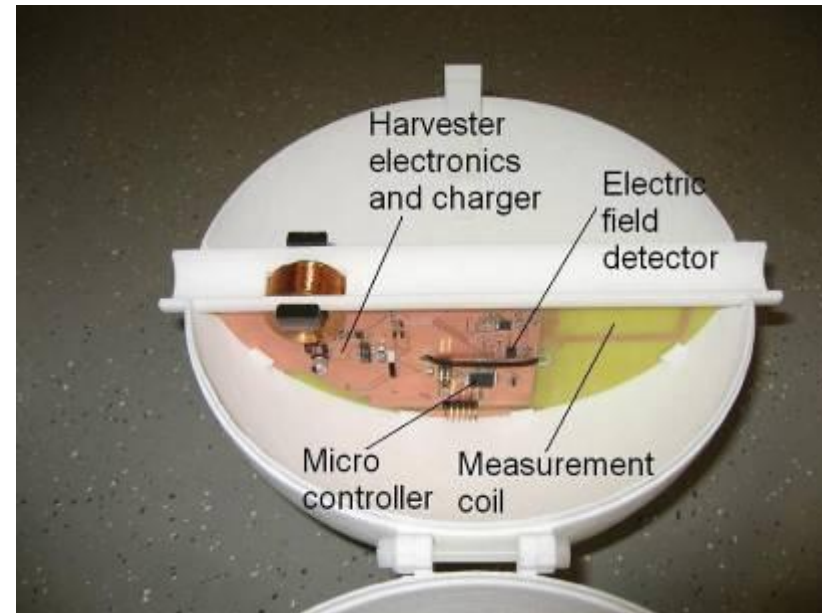
## Principle of operation

- Current measurement based a coil magnetometer
- Electric field is measured for coherent noise rejection
- Inductive battery charging based on energy harvesting from the power

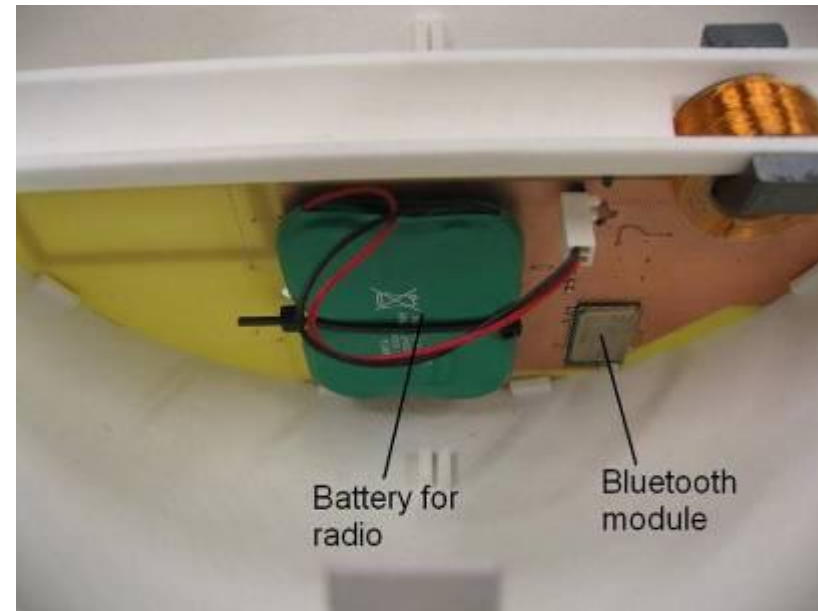
## Communication

- Data transmission by Bluetooth in this prototype
- Radio in final product will be changed to a more suitable type
- Battery for radio is charged with the harvester
- Alarm can be sent even when the current has stopped
- The device can operate for days using battery only (depends on the transmission interval)

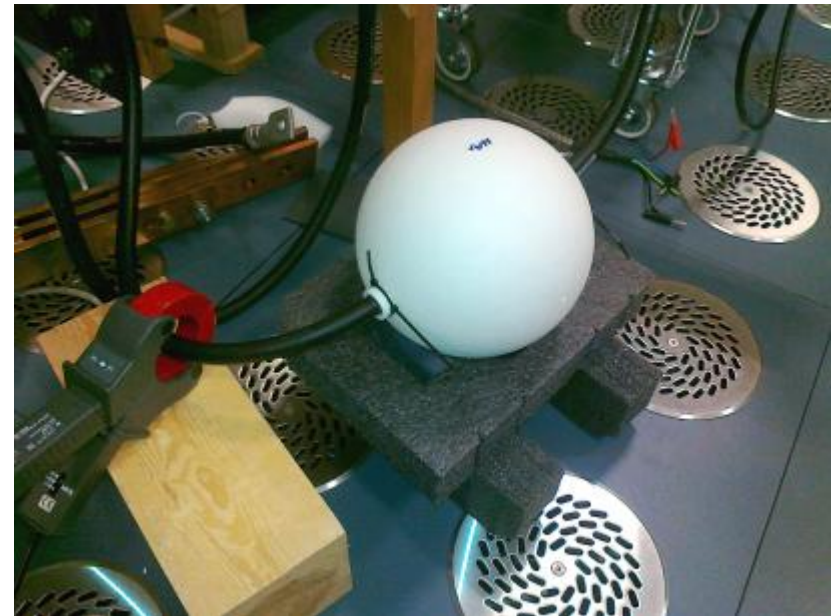
## Test measurement 1: High current setup

- Measurements done at MIKES
- Parameters measured
  - Linearity of current sensing
  - Error estimation of current sensing
  - Harvested power
- Line currents 10-300 A (voltage was low)
- Conductor diameter was 18 mm

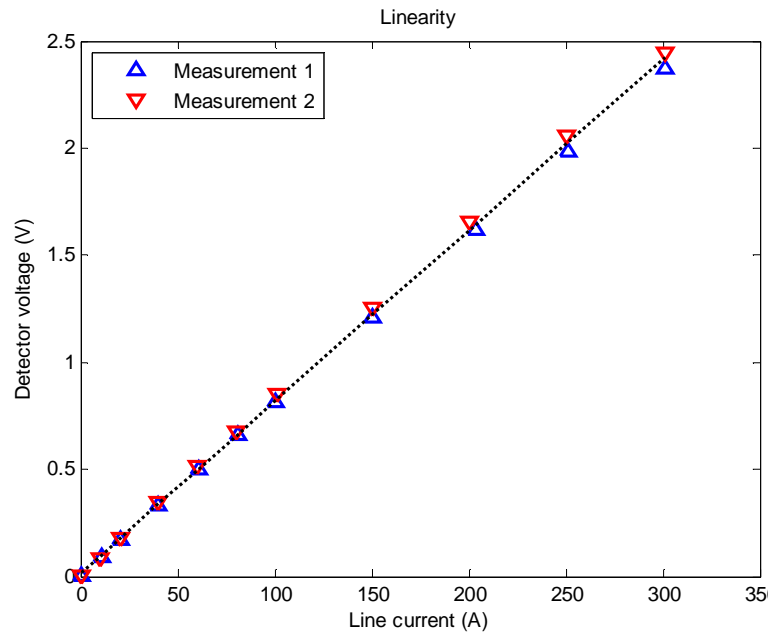
## Test measurement 1: Results, linearity and harvested power

Linearity and sensitivity is good  
 $\pm 1\%$  full scale accuracy

- After post-calibration the error is  $\pm 2.5$  A in a range of 10-300 A
- This corresponds to  $\pm 1\%$  full scale accuracy

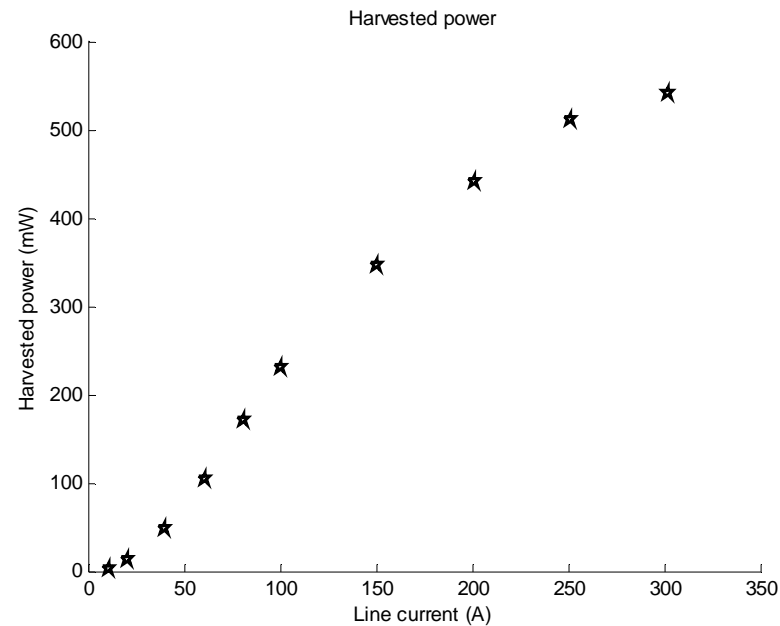
Harvested power is more than adequate  
tens on mW on typical conditions

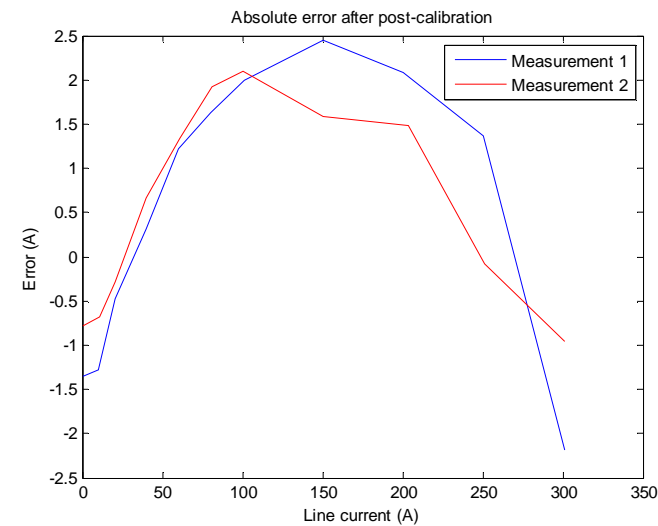
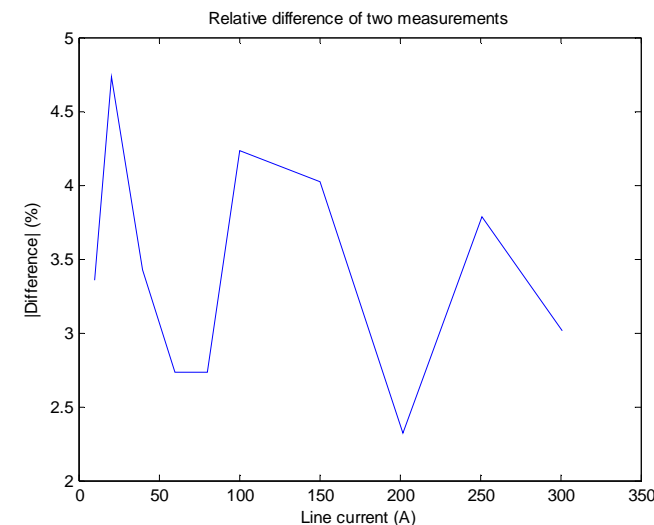
## Test measurement 1: Results, accuracy

- The dominating error source is installation: it can cause 5% systematic gain error
- This is caused by small variations of the distance between the sensor and the line
- Can be improved with a tighter tube

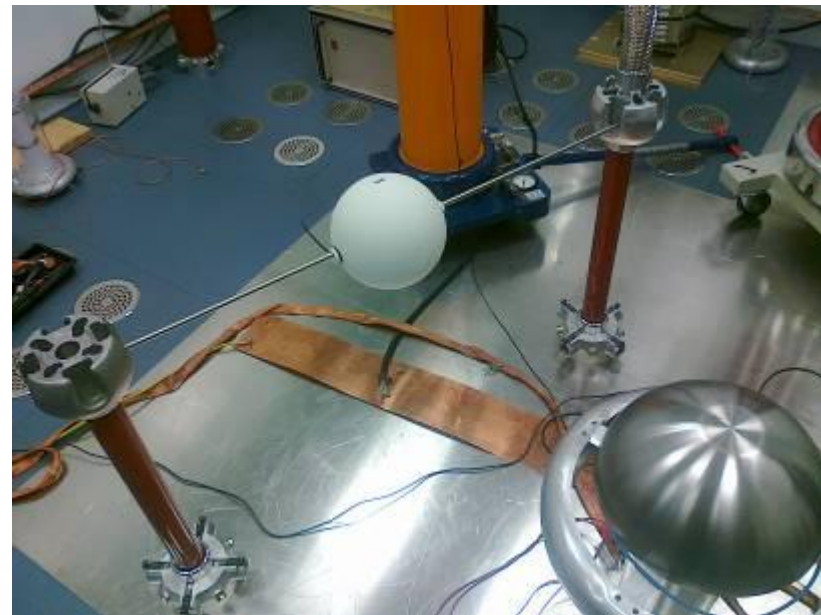
## Test measurement 2: High voltage setup

- Measurements done at MIKES
- Measured parameters
  - Survival test
  - Common mode error estimation
- Line voltages 5-20 kV, RMS
- No current in the line
- Device was mounted on a solid bar at a height of  $\approx 80$  cm from a ground plane
- Operation of the current measurement was verified after the high voltage test

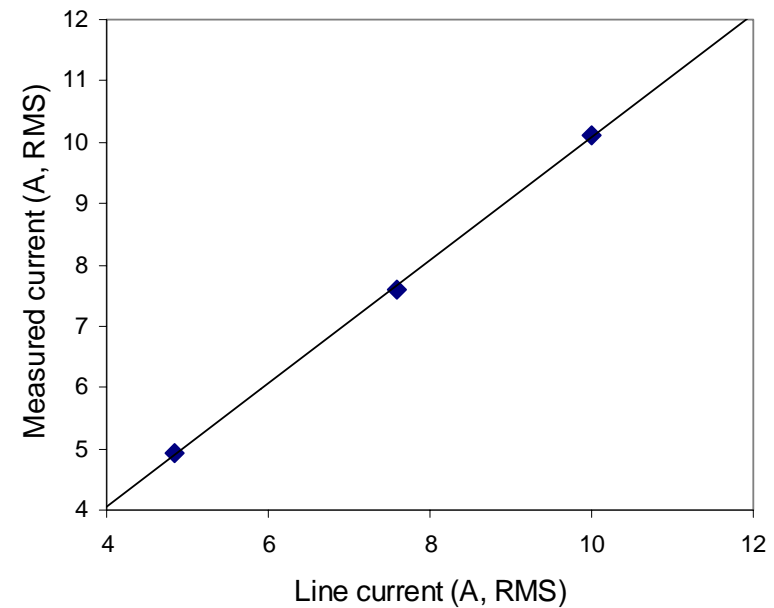
## Test measurement 2: Results, survival test

- The device did not break up to 20 kV RMS, less than 1 m distance from ground (extremely hard condition)
- Current measurement was still working and linear after the high voltage test

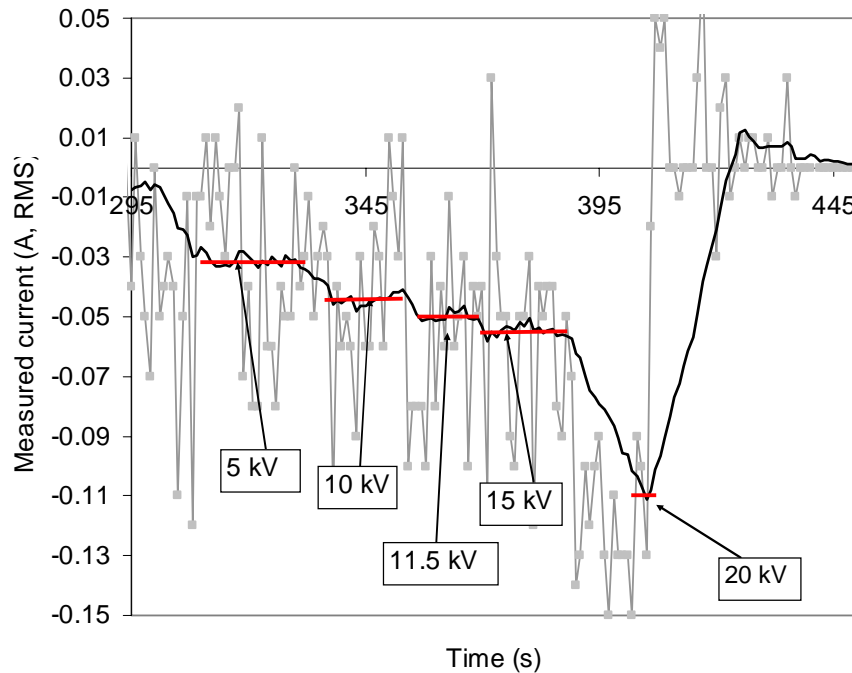
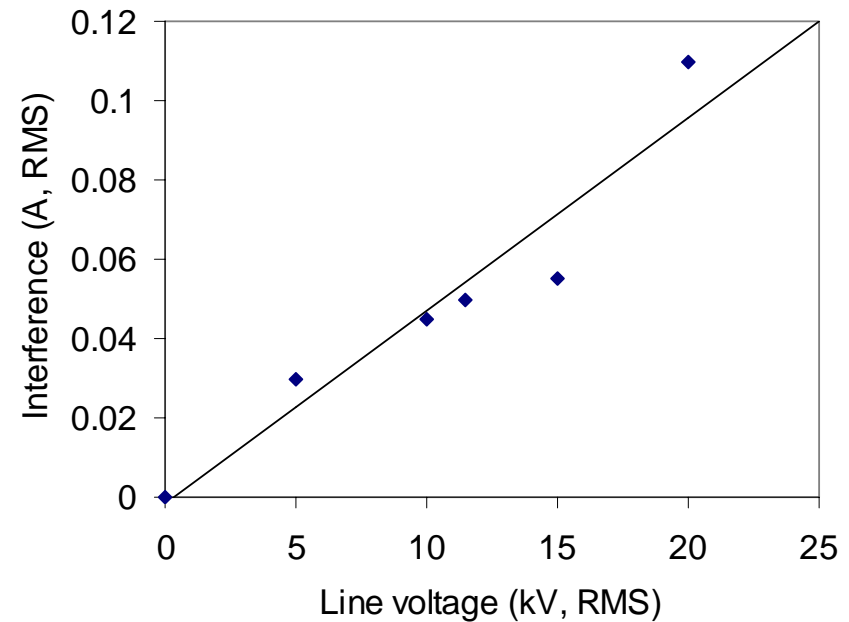
## Test measurement 2: Results, common mode error

- Effect of common mode interference is very hard to detect because it is so small
- The error is order of 100 mA at 20 kV, RMS

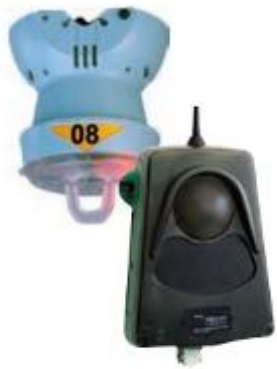
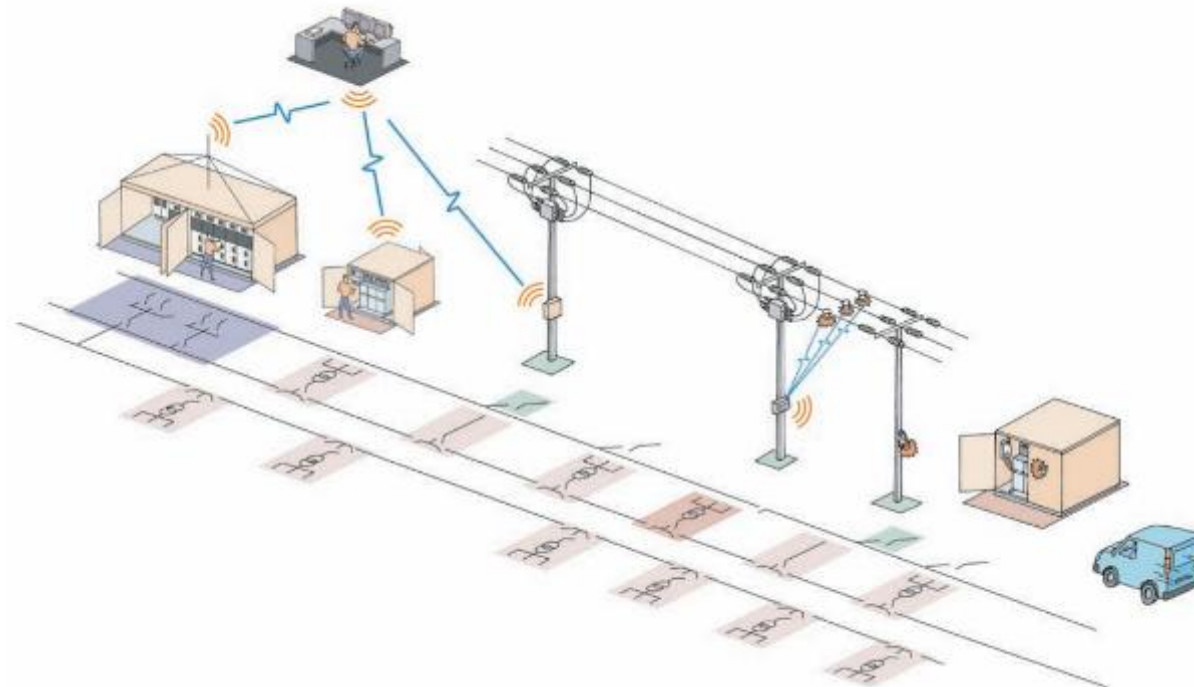
Flite16/G200

- [Flite](#) from Schneider Electric
- Clips on to the line
- Relies on **batteries**
- Transmits data using radios on the unit and on the poles
- No price information available
